RED CLIFFS GOLF CLUB INC.
Preliminary Report to Golf Victoria
following the floods in the Sunraysia district on 4th February 2011.

Report to Red Cliffs Golf Club Committee of Management
10th February 2011

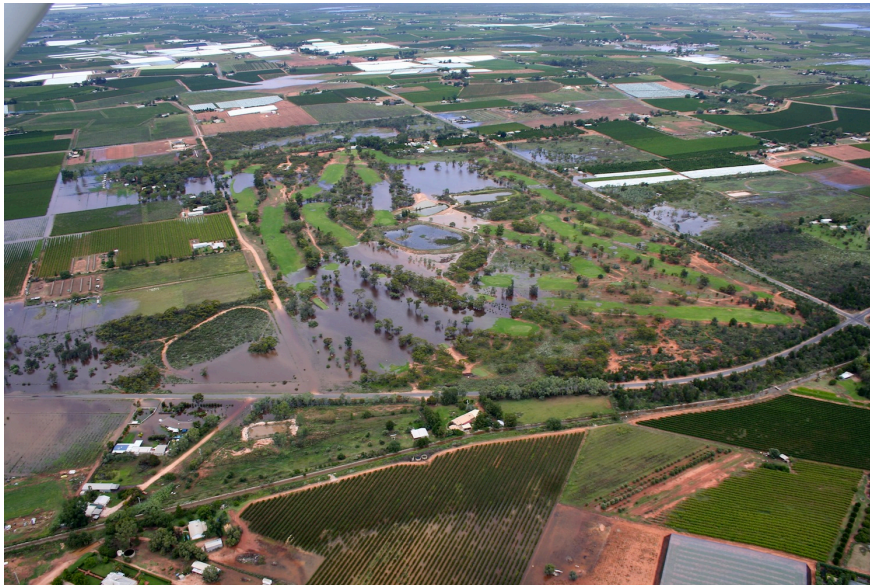
Below is an aerial photo taken by the local newspaper group the day after the storm. Given that I've ordered a copy for the club's files, I have been given permission to include it in this preliminary report to Golf Victoria.

- The flooded 3rd, 4th & 5th holes can be seen lower left.
- The flooded 7th fairway can be seen top left.
- The flooded 10th & 11th fairways and turf farm can be seen centre & centre right.
- The almost unaffected back nine can be seen lower right. Unfortunately the flooding on the 10th & 11th holes has effectively rendered this section of the course unusable.
